## TOPIC: Crack damages in Exhaust Collector and Exhaust Ducting.

### CCRM™ – Crack Cold Repair Method.

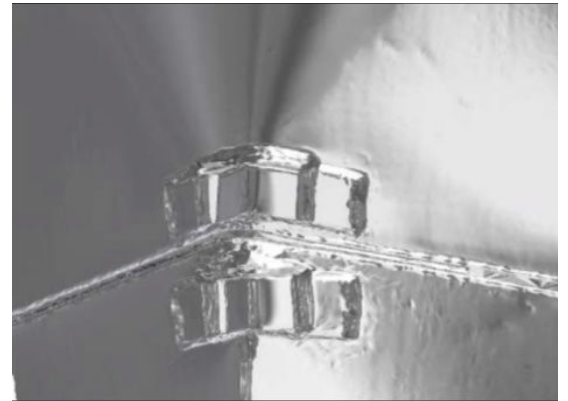
Processed scan of a crack damaged duct corner. The damage has been tried repaired by drilling crack end holes, grinding and welding the crack, and by welding on patches. The repair failed as both the repair welded crack and welded on patches cracked after a limited number of Start/Stop Cycles.

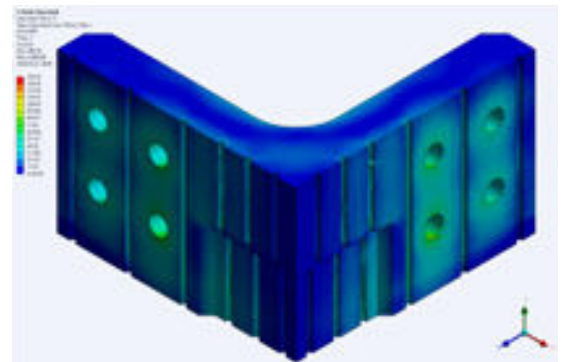
FEM-analyses of CCRM corner reinforcement. 20-year life with 500 Start/Stop Cycles, with a safety factor of 2,6.

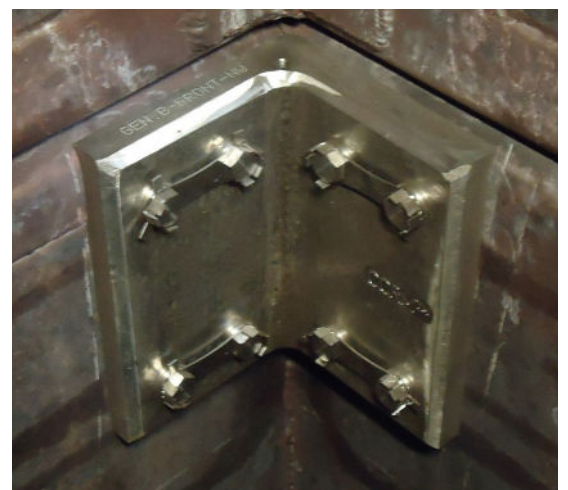
Crack damaged corner reinforced with CCRM™.

- Field scanning of damaged areas
- Install CCRM™ Reinforcement elements
- CCRM™ fasteners type self-aligning HotBolt™, material Inconel 625
- Pre-tension HotBolt™ in steps to avoid embedment relaxation
- Protect HotBolt™ Extension Sleeve from heat radiation
- Bolts to be locked with HotBolt™ Locking Plates.
- Note: Repair welded cracks or welded on patches will re-crack after a limited number of Start/Stop Cycles.
