TOPIC: Blown out and damaged flange gasket causing exhaust leakage.

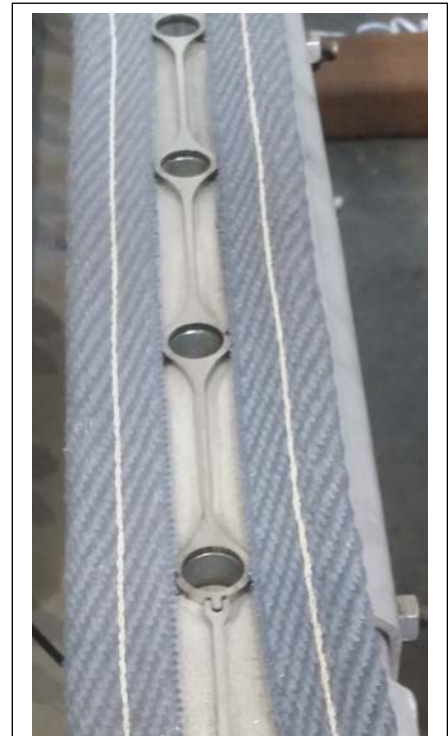
HotSeal™ Gasket with Spacer Shim for exhaust duct flanges.

For 723° C continuous operating temperature

- Patented by Noble Installation
- Designer for use on buckled and non-parallel duct flanges
- Designed with spacer shim to secure correct bolt pre-tension
- Material selection: Inconel 601 seal rope, Inconel 601 reinforced long fiber Silica jacket
- Inconel AISI 321 Spacer Shim

- ✓ Separate flanges, remove old gasket and clean flange gasket surface
- ✓ Install new gasket type HotSeal™ with Spacer Shim to secure correct gasket compression and a stiff bolt connection with a defined pre-tension stress.
- ✓ Install new fasteners type HotBolt™ with extension sleeve
- ✓ Pre-tension bolts in 3 steps to avoid embedment relaxation
- ✓ Protect HotBolt™ Extension Sleeve from heat radiation
